Restoration Plan

Waikākahi Stream

Prepared for:

Ngā Wairiki Ngāti Apa

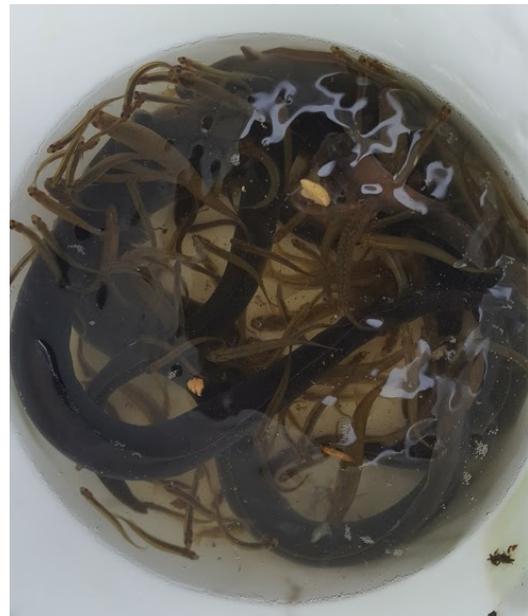
EELS AND ĪNANGA FROM A TRAPPING SITE ON THE WAIKĀKAHI

Īnanga were abundant in the trapped section, which was just below the most significant downstream fish barrier (see Figures 5 and 6 - 'Farm Crossing Culvert'). This barrier may be corralling the Īnanga in this section, although there were Īnanga spotted in other sections downstream too and the numbers may be similar in other sections.

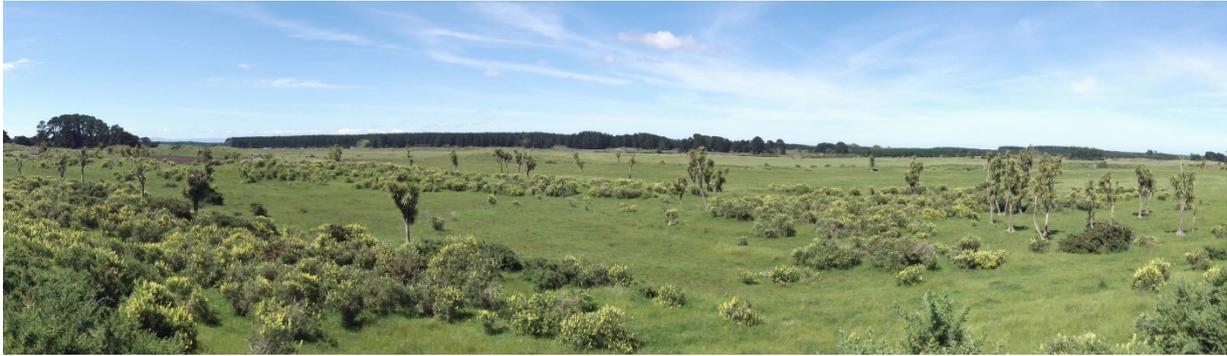
Remnant tī kōuka dot paddocks in lower lying areas between dunes, but have little opportunity to regenerate due to browse pressure and competition from rank pasture grass. Small stands of raupō and harakeke are found in low lying areas between dunes and in ponds north of Raumai Road near the gas valve. These areas have potential to provide important areas of biodiversity, especially for native birds.

MATURE TĪ KŌUKA DOT LOWER LYING AREAS BETWEEN LOW VEGETATED DUNES

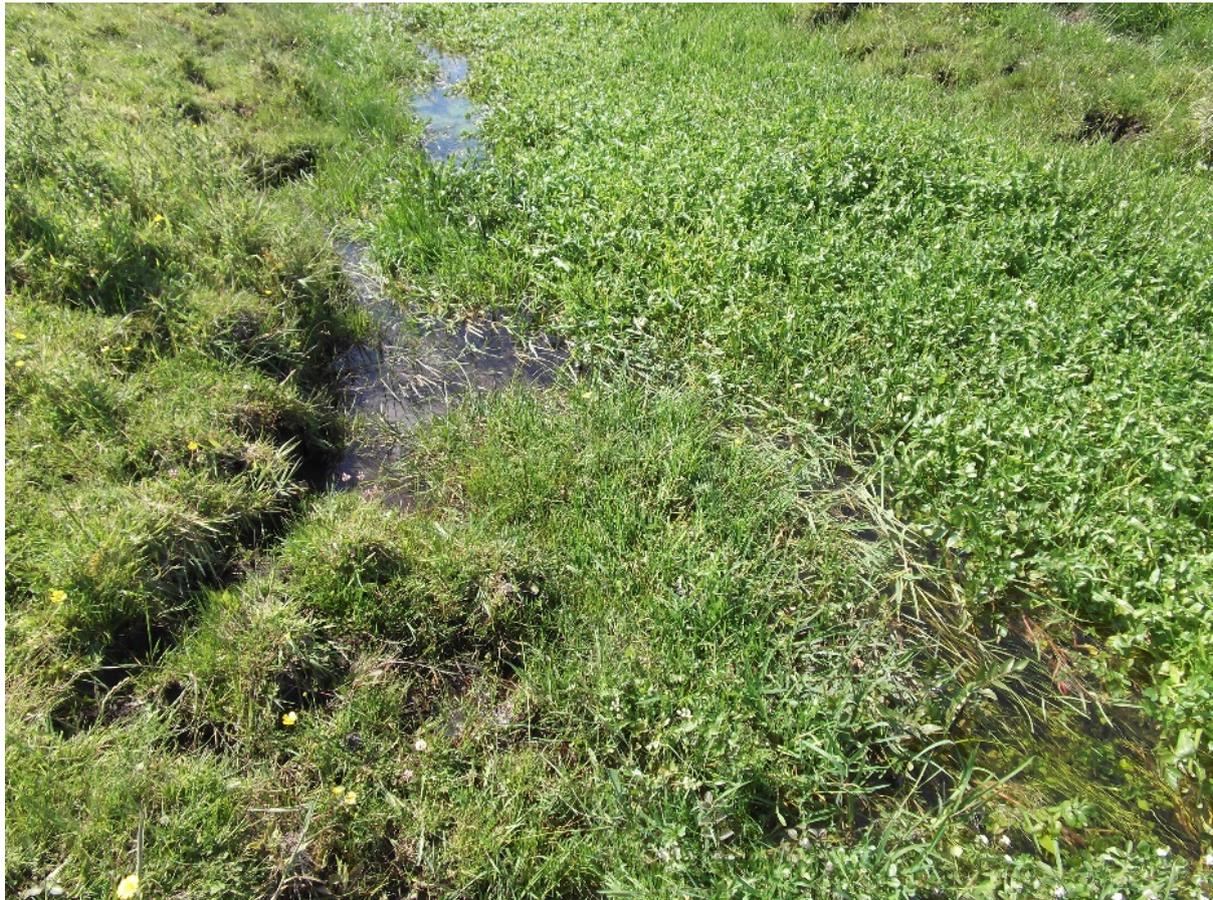
STOCK ACCESS TO THE STREAM HAS REDUCED STREAM-EDGE VEGETATION AND COLLAPSED THE BANK

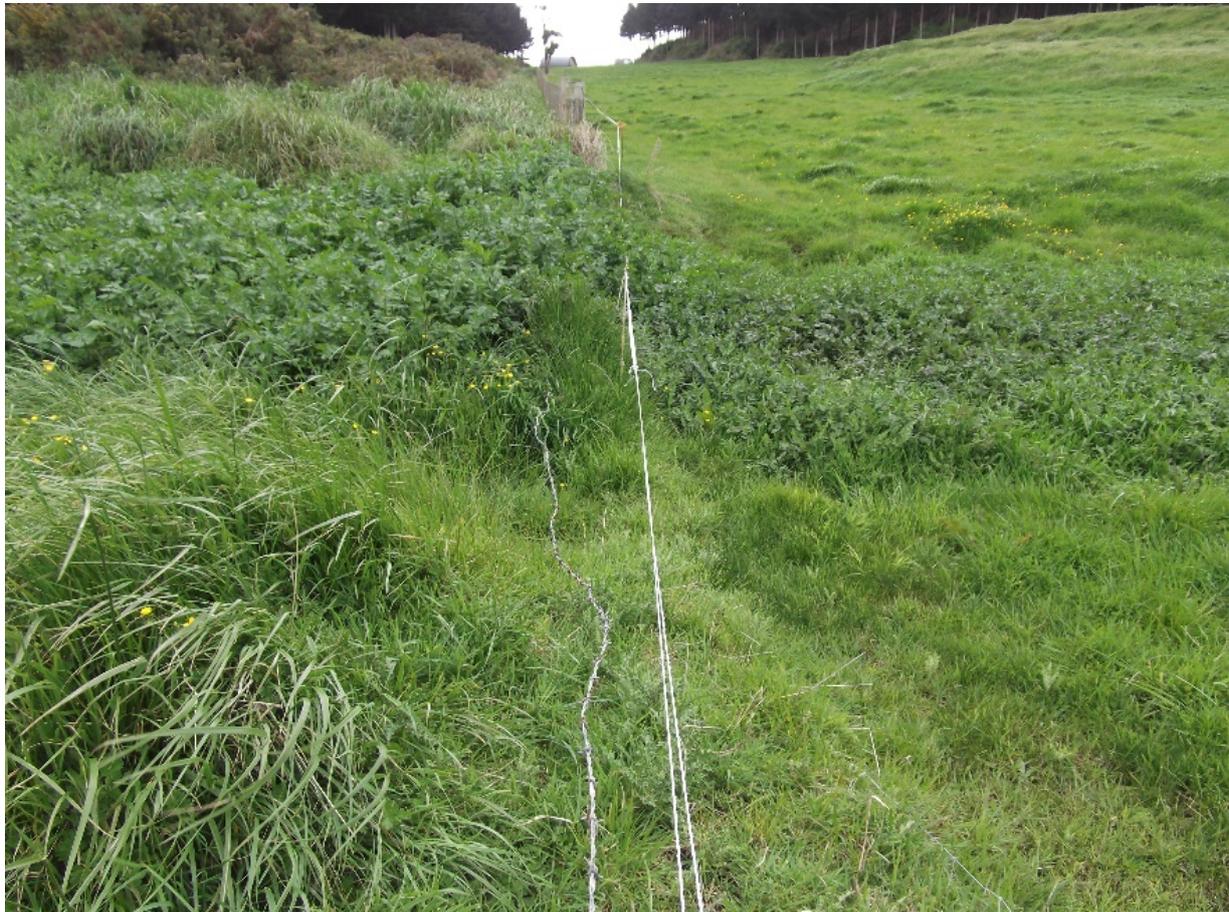
root. Cattle graze water celery, reducing the amount of plant material, but do not eradicate it. As water celery favours nutrient-rich habitat, cattle access to streams may also benefit water celery growth.

CATTLE BROWSE WATER CELERY BUT DO NOT ERADICATE IT, AS EVIDENCED HERE BY THE GRAZED (RIGHT) AND UNGRAZED (LEFT) AREAS.

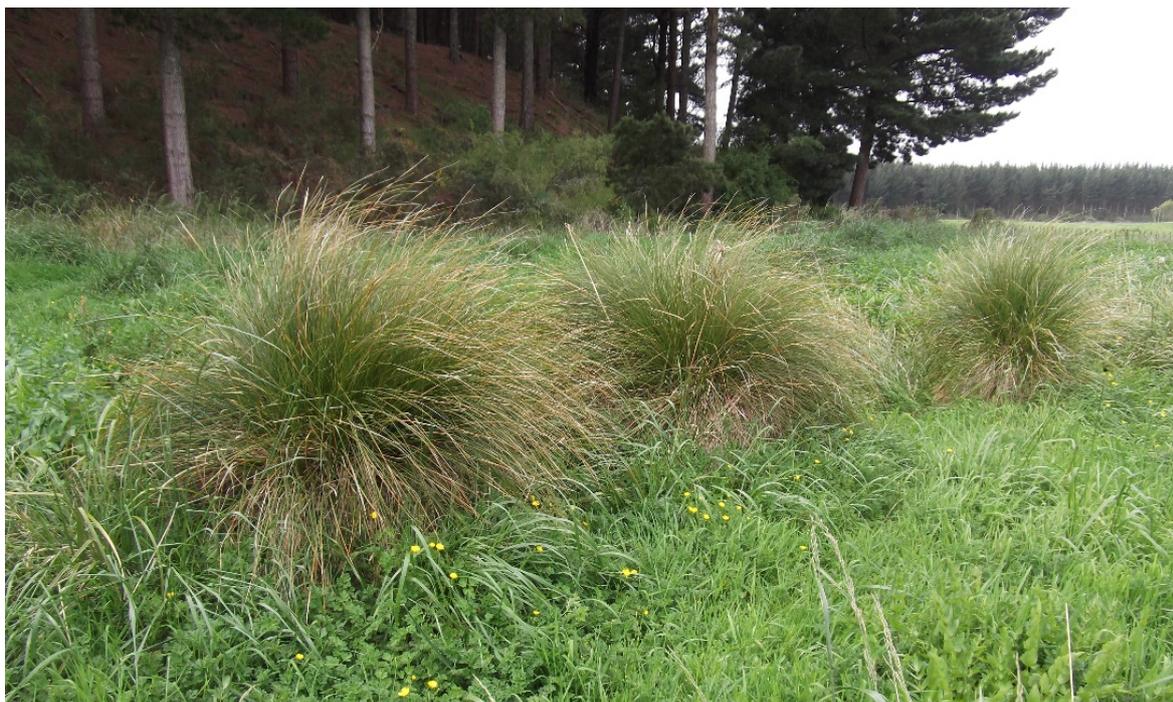
LARGE CAREX SECTA CLOSE TO WAIKĀKAHI STREAM. CAREX SECTA WOULD HAVE BEEN COMMON ALONG THE STREAM AND COULD PLAY A VALUABLE ROLE IN RESTORING NATIVE RIPARIAN VEGETATION. DENSE PLANTING OF C. SECTA AT THE WATER EDGE WITH TOETOE, HARAKEKE AND NATIVE TREES BEHIND WILL CREATE STRONG SITE COMPETITION AND SHADE TO EXCLUDE WATER CELERY.

Sections of stream to be restored must be fenced to prevent stock access, and will ideally have pre-existing meanders. Fencing needs to be well set back from the stream edge to allow room for an adequate depth of planting. Fencing and planting will reduce nutrient input to waterways which will further disadvantage water celery.

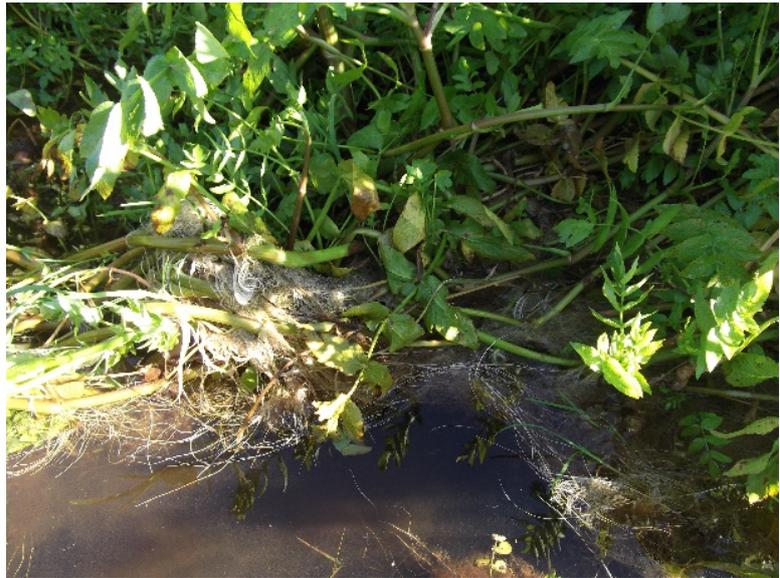
WATER CELERY SHOWING FREE FLOATING ROOTS THAT HAVE NOT ROOTED INTO THE STREAM BED

culverts. Because of these factors physical removal of water celery is the suggested method of control, at least for the initial trial planting sites (Champion, James, Singers, & Bodmin, 2011).

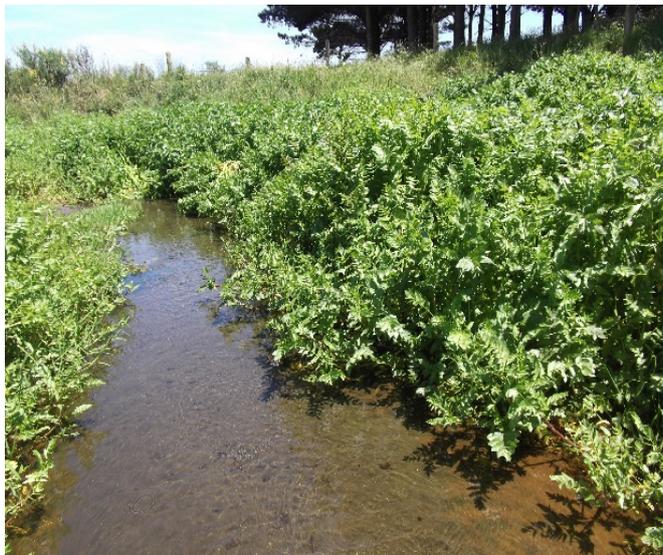
stream sediment. Occasional small water celery plants were also rooted in the sandy stream bed at a water depth of up to 30 cm. Native plants could occupy these areas on the stream bank where water celery takes root and replace the weed.

SECTIONS OF STREAM WITH OPEN WATER WHERE WATER CELERY IS ROOTED INTO THE BANKS BUT NOT THE STREAM BED OFFER GOOD OPPORTUNITIES TO EXCLUDE THE WEED WITH DENSE NATIVE PLANTING.

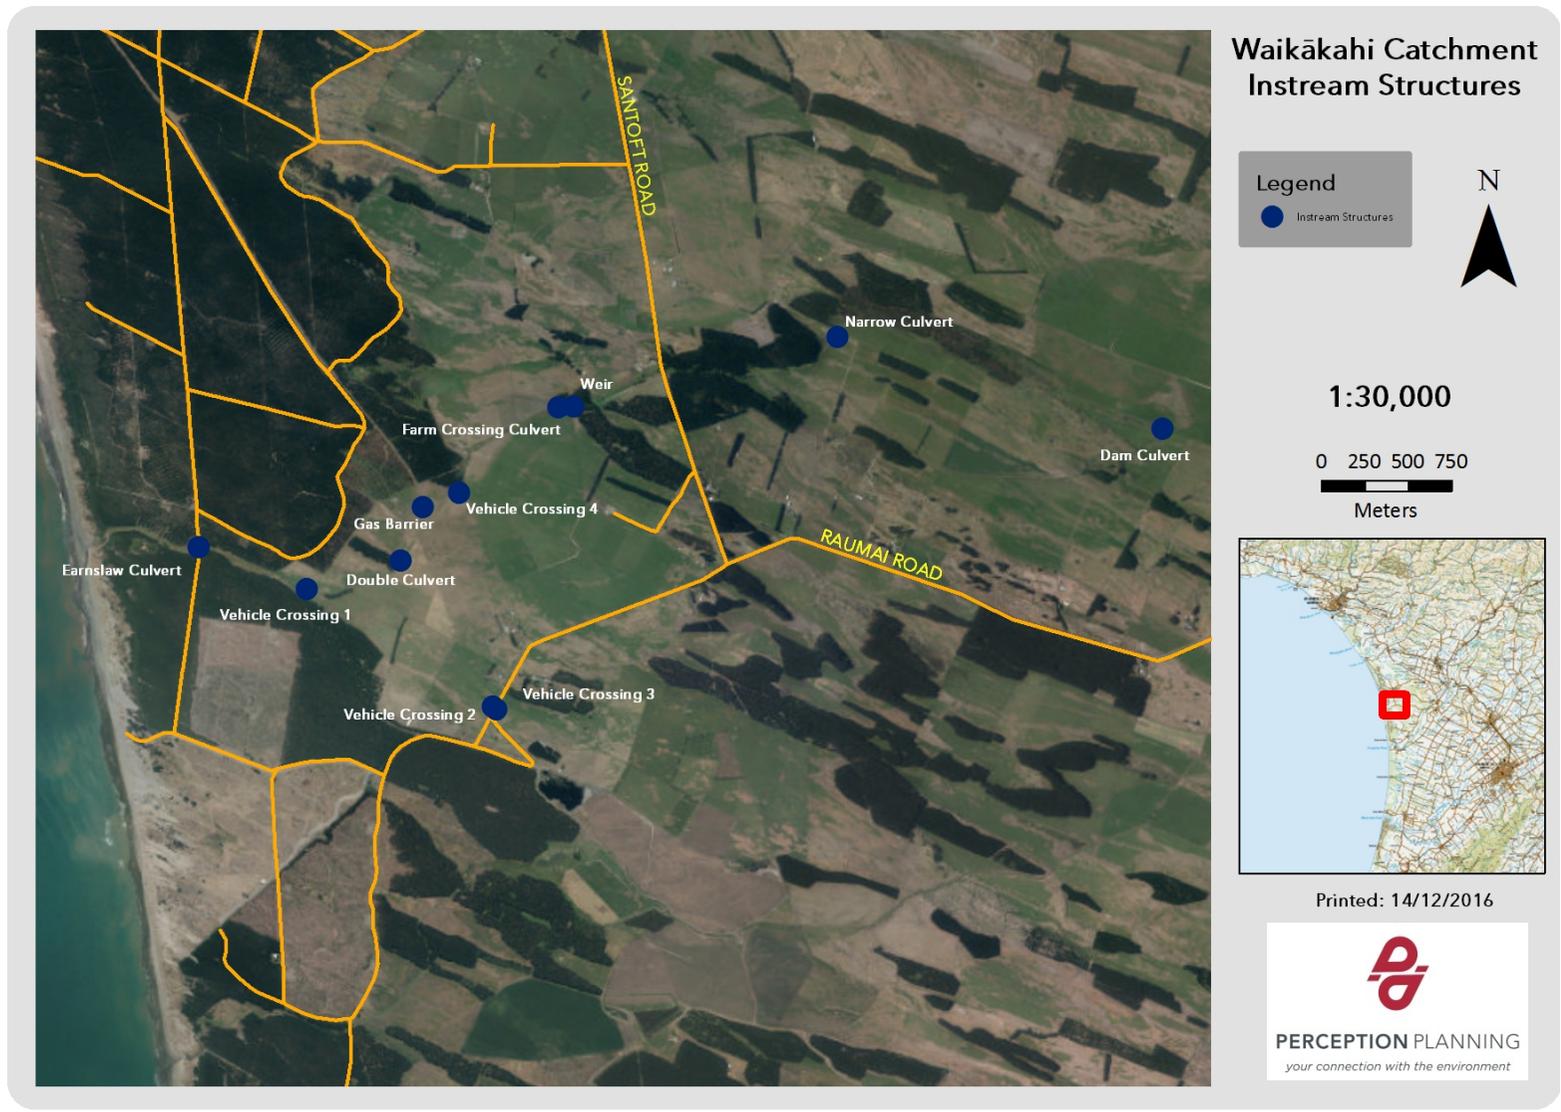
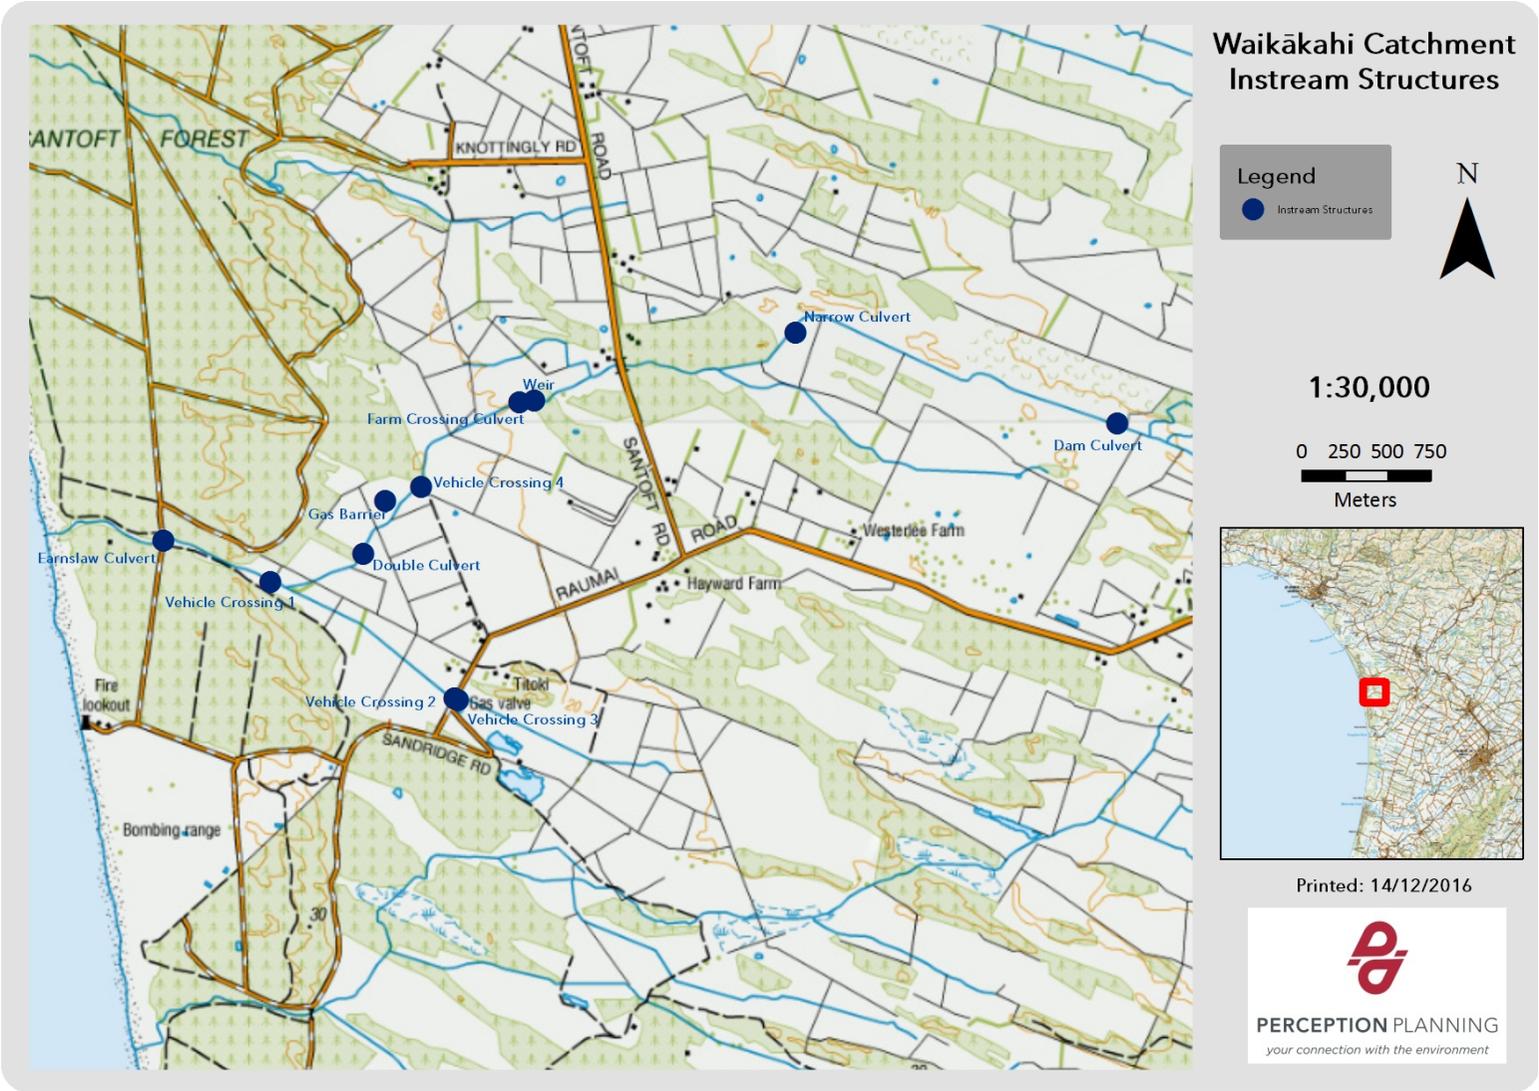
FIGURE 5: AERIAL MAP OF INSTREAM STRUCTURES AND VEHICLE CROSSINGS IN THE WAIKĀKAHI CATCHMENT

FIGURE 6: TOPOGRAPHICAL MAP OF INSTREAM STRUCTURES AND VEHICLE CROSSINGS IN THE WAIKĀHAHI CATCHMENT

Elvers were seen gathering below the most downstream fish barrier, located in the Earnslaw Forest in Section 1 (see Figures 5 and 6 - 'Earnslaw Culvert'). Their efforts to move upstream were being thwarted by the swift water in the culvert, and it was obvious the culvert was acting as a velocity barrier for these elvers. Some eels and Īnanga must manage to get through, given the fish found upstream. Nevertheless, numbers upstream would likely increase should this barrier be removed.

Alternatively, constructing a bridge often avoids passage issues. Particular fish barriers found in the Waikākahi are discussed under the relevant stream section headings in Part Two, however the key ones to note are the Earnslaw Culvert, the Farm Crossing Culvert, and the weir (see Figures 5 and 6).

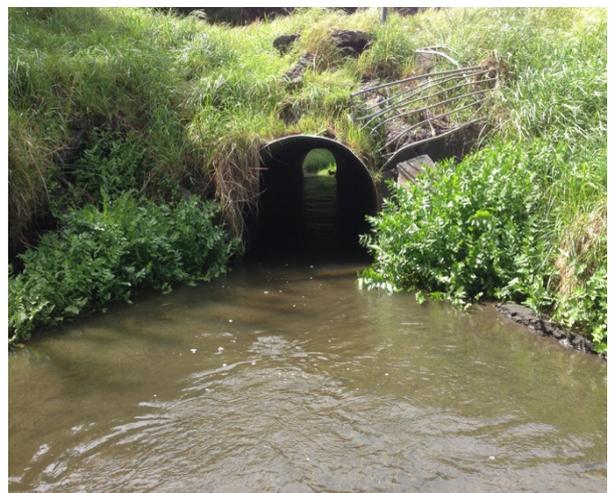
As mentioned in the overview section, there is a culvert in this section that is acting as a velocity barrier for elvers, and possibly īnanga too (see Figures 5 and 6 - 'Earnslaw Culvert'). This is a high priority to remedy, and will help open up the rest of the catchment to these juvenile eels.

EARNSLAW CULVERT - VELOCITY BARRIER UNDER EARNSLAW ROAD

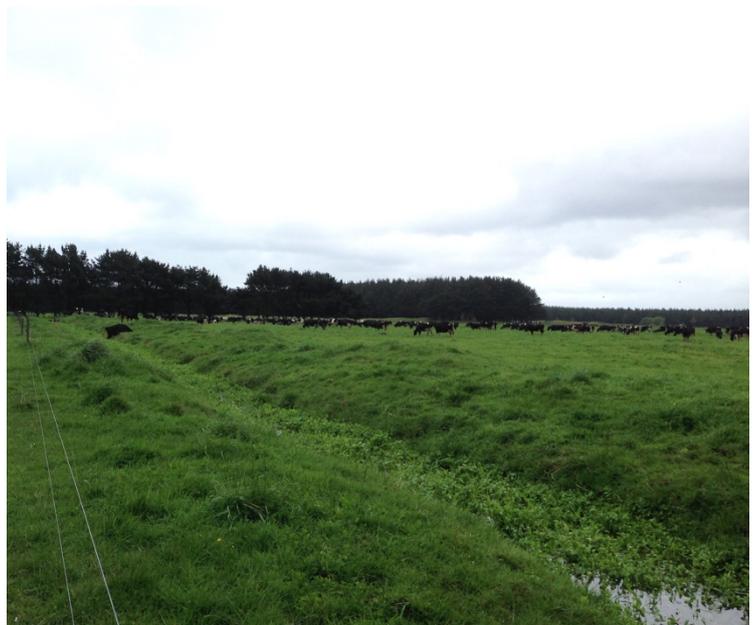
COWS WITH STREAM ACCESS ON THE LOWER TRUE LEFT TRIBUTARY

There are three vehicle and stock crossings in Section 2; these need to be culverted or bridged to prevent both contaminants from the vehicles

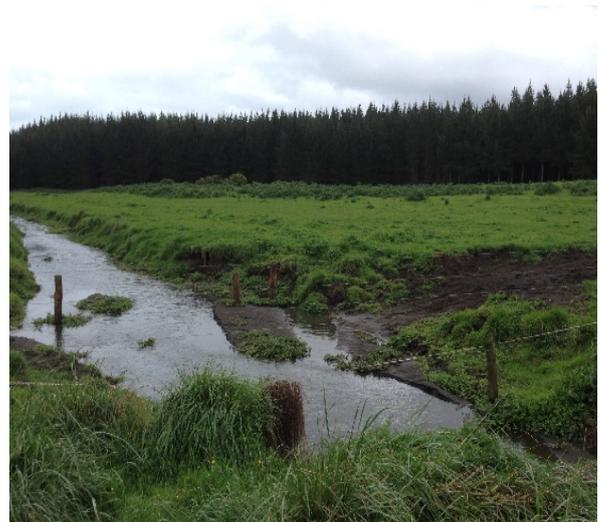
VEHICLE CROSSING 1, IN MOST DOWNSTREAM Paddock

In the lowest, most downstream paddock in this section below the confluence of the true left tributary and the main stem, there is a vehicle and stock crossing that needs to be bridged (see Figures 5 and 6 - 'Vehicle Crossing 1'). Stock crossings are addressed in the Sustainable Dairy: Water Accord, with an undertaking by the dairy industry to "Implement measures to ensure 100% of regular stock crossing points are either bridged or culverted by 31 May 2018." (Dairy Environment Leadership Group). It is also a requirement under the One Plan Policy 14-5 (Horizons Regional Council, 2014).

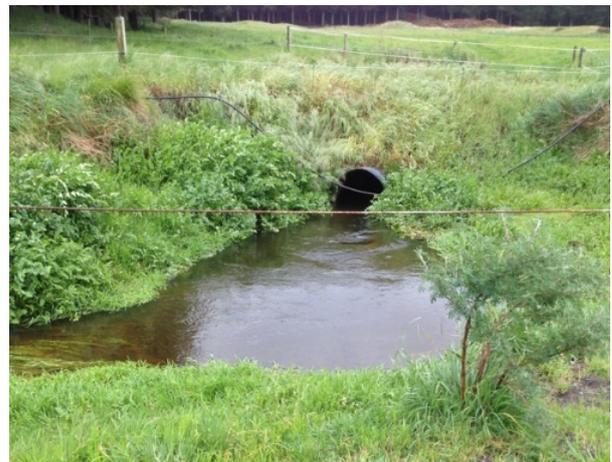
ERODED CULVERT

Moving across to the main stem, there is a culvert comprising two different sized pipes that had washed out around the join (see Figures 5 and 6 - 'Double Culvert'). Again this does not appear to be a fish barrier as fish were found upstream, but will be causing ongoing work for the farmer. It would be better replaced with a single, larger culvert.

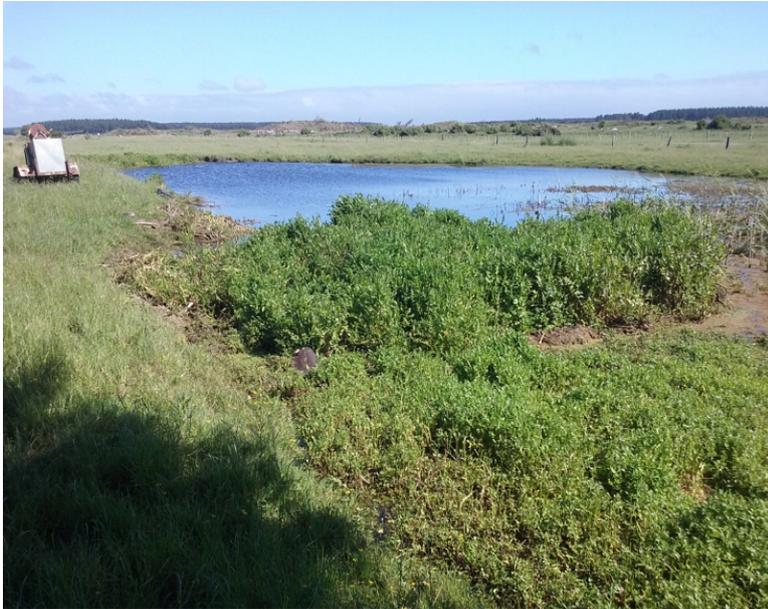
SMALL POND WITH STOCK DAMAGE. RAUPŌ IS VISIBLE TO THE RIGHT OF THE PICTURE.

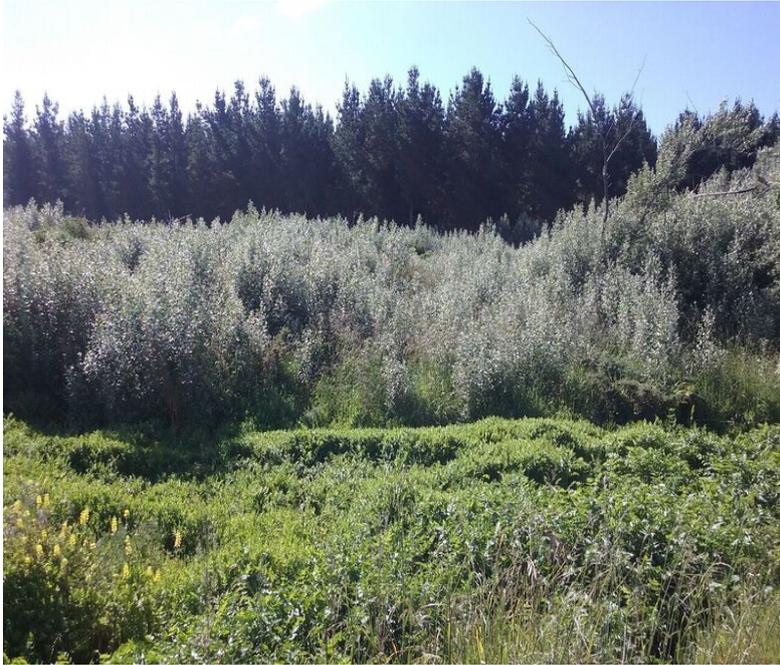
The main area of terrestrial weeds is found in the expanding white poplar infestation. White poplar is expanding through pine slash and into the pine plantation from mature plants on the stream edge. In this area, elderberry, gorse and lupin are common, and the occasional boxthorn is present. Boxthorn are also present close to the junction of the main stem and the true left tributary. The presence of these weeds increases the difficulty and expense of establishing native riparian planting in this section.

WHITE POPLAR INFESTATION EXPANDING FROM MATURE PLANTS NEAR THE STREAM

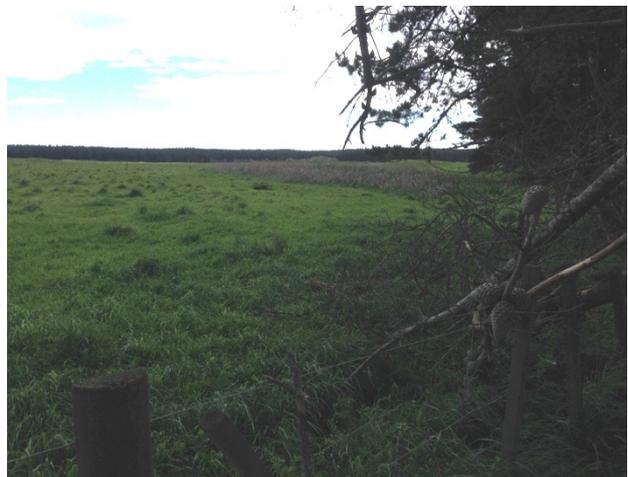
The stream bottom is still sandy in this section. The topographical map indicates that there is a tributary flowing in an easterly direction on the true right; however this was little more than a damp area in the paddock in reality. There is, however, a small raupō wetland that is not marked on the topographical map, located at the point where the tributary is marked to begin.

SMALL RAUPŌ WETLAND

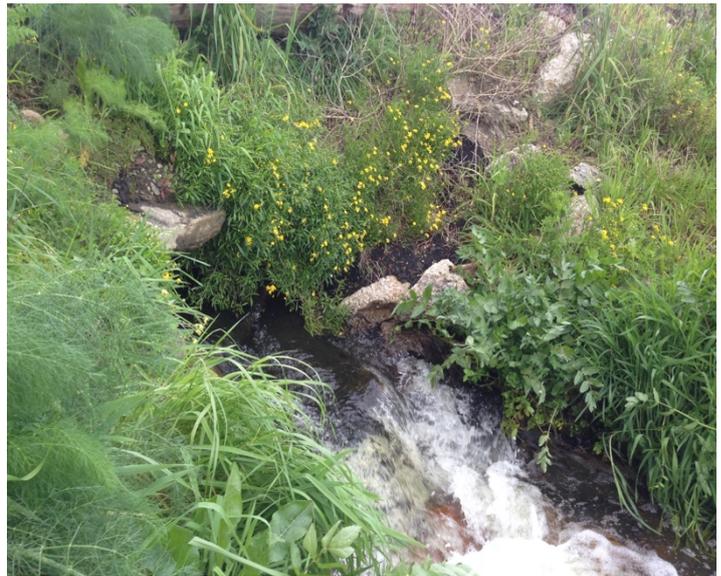
This section contains two considerable fish barriers. The first, as described above, is a velocity barrier created by a small culvert underneath a farm vehicle crossing. Rocks have been placed beneath the outlet, which will assist fish passage somewhat, but in general this culvert (and the small one beside it that is designed for higher flows) needs to be replaced with a much larger capacity culvert. A box culvert would probably be best. Once replaced, the streambed will even out, with sediment currently trapped upstream moving downstream. It would be wise to allow this to happen before undertaking downstream planting.

FARM CROSSING BARRIER

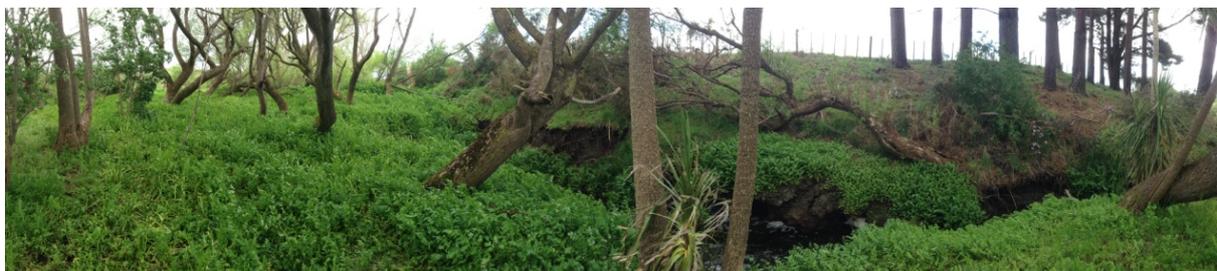
OLD WEIR AND SURROUNDING AREA

Removing this weir will result in substantial realignment of the streambed, with a channel likely to form in the upstream area that is currently a wide wet swathe. Again, the streambed will even out, with sediment upstream moving to fill in areas downstream. Planting in this area should be delayed until the streambed has realigned.

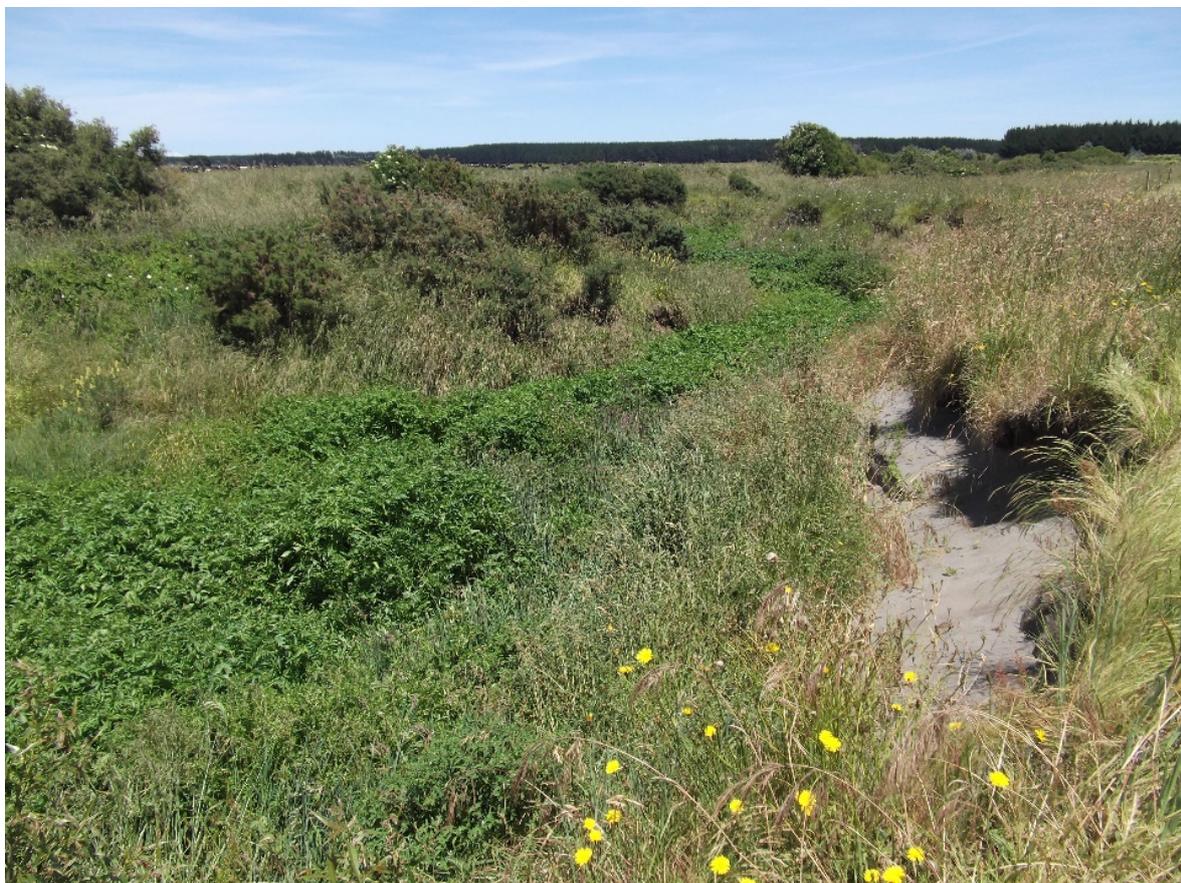
Below the weir and vehicle crossing are good sites for native riparian planting to increase biodiversity and compete with water celery. The stream has natural meanders and fences are set far enough back from the stream on both sides to allow for a full range of planting, from *C. secta* at the stream edge to toetoe and harakeke and tree species further back. Water celery is abundant but the stream still has areas of open water. Water celery is predominantly rooted at the stream edge, with plant material in the stream free-floating rather than rooted into the stream bed itself. This makes removal easier and competition planting more likely to be successful. There is the potential to plant 600 metres of stream below the vehicle crossing. However, before planting can be undertaken the fish barriers created by the vehicle crossing and the weir ought to be remedied.

LOOKING DOWNSTREAM FROM THE VEHICLE CROSSING AT POTENTIAL RIPARIAN PLANTING AREA. WIDE FENCING SET-BACKS AND NATURAL MEANDERS MAKE THIS A GOOD SECTION OF STREAM TO PLANT.

Below the vehicle crossing, boxthorn, elderberry and establishing crack willow are growing together in thickets mainly on the true left, and these should be controlled prior to planting. There is easy access for a gun and hose unit and spraying would be straight forward. Weeds should be left standing to provide shelter for native plantings. Gorse is also common but does not need to be controlled away from the fence line as it will

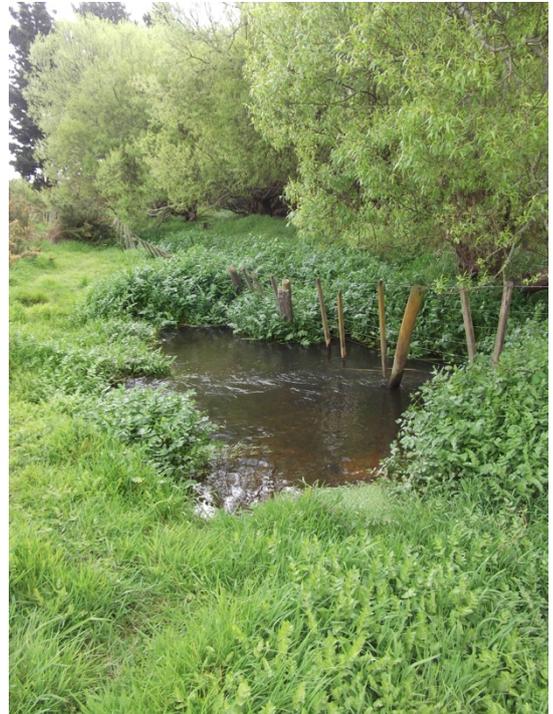
MATURE CRACK WILLOW AT THE UPSTREAM END OF SECTION 4

Crack willow is likely to invade lower sections of Waikākahi Stream from broken branches moving down stream and it should be controlled if willow control is undertaken in Section 3. Drilling and poisoning could be easily achieved as there is reasonable access to the trees. If dead standing trees are to be removed from the stream to prevent material possibly damming on the road culvert this would need to be completed when the pines on the true right are harvested. Because of the wide stream bed water celery will be hard to displace by planting of native species and this site is not recommended for restoration planting in the short term. Wandering willie is also likely to be transported downstream where it could establish new infestations. If riparian planting and weed control is undertaken in section 3 and further down stream wandering willie should also be controlled. Control could be undertaken by spraying in summer low flows using glyphosate (20 ml/L + penetrant), however, areas close the the stream should be removed by hand.

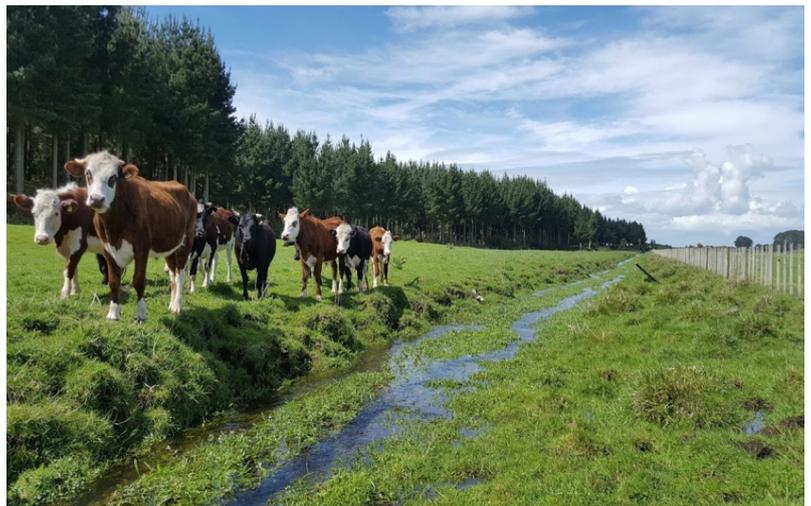
STOCK ACCESS TO THE UNFENCED PART OF SECTION 5

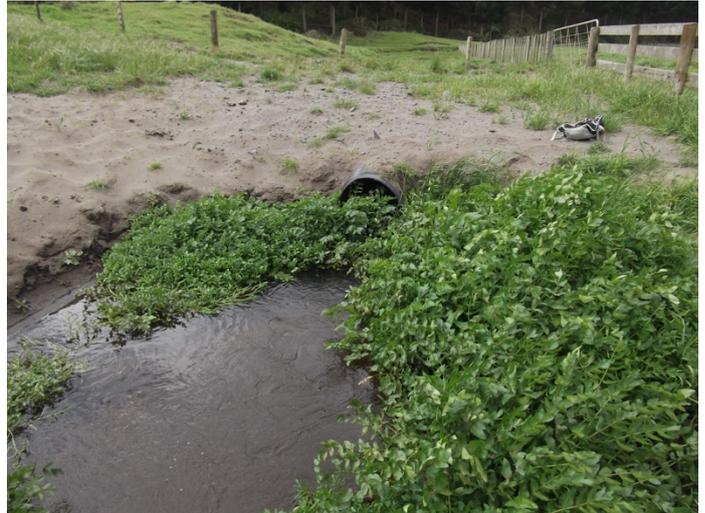
There is a small culvert in this section that is much narrower than the stream bed (Figures 5 and 6 - 'Narrow Culvert'). Given the current downstream blockages, replacing this culvert is a low priority. We recommend replacing the downstream fish barriers then assessing this culvert 1 to 2 years following that, to determine whether it is a velocity barrier for īnanga. It is not currently perched but may erode out over time.

NARROW CULVERT

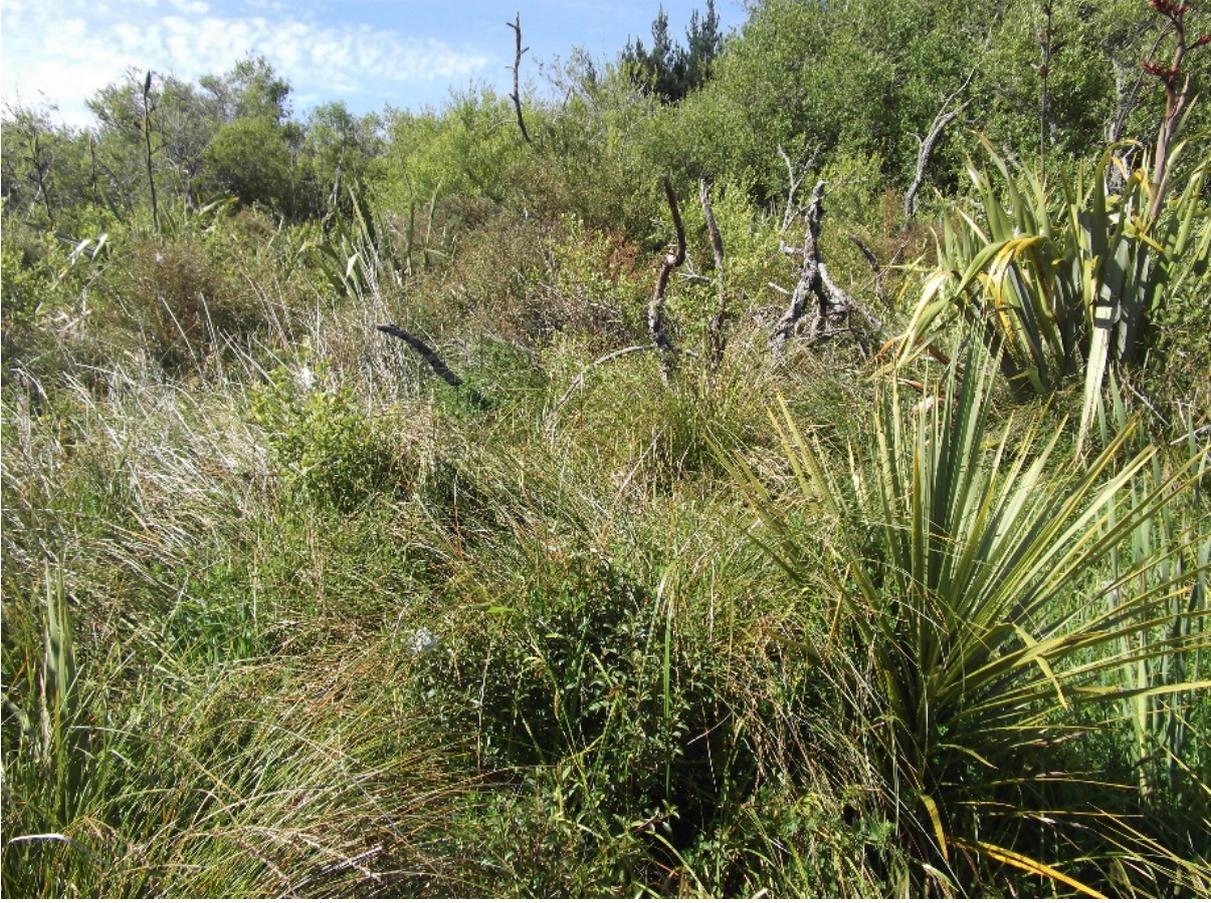
The wetland is fenced except for the border with the pine-forested dune, which is not grazed. There was some evidence of past pugging indicating stock had been in to the wetland but no signs of damage to vegetation. In drier parts of the wetland grey willow forms the bulk of the canopy with smaller areas of taller crack willow. In wetter areas grey willow are common but are not currently out-competing *C. secta*, harakeke and raupō.

ONE OF THE WETTER AREAS IN THE CENTRE OF THE WETLAND WITH HARAKEKE, TĪ KŌUKA, RAUPŌ, *C. SECTA*, *COPROSMA PROPINQUA* AND SAPLING GREY WILLOW. MATURE GREY WILLOW FORM A CANOPY IN THE BACKGROUND

An extensive grey and crack willow canopy has replaced the former native swamp forest and is causing the further decline of biodiversity values. Grey and crack willow have been successfully controlled in wetlands by aerial spraying and follow-up ground control. The closed canopy of the willow will partially protect the native vegetation underneath from spray, although native species in the canopy and those in open areas can be affected. At Kopuatai Wetland aerial spraying of willows with glyphosate in 2002 resulted in excellent control of willows with very little damage to non-target species, such as indigenous sedges in the understory (Reeves & Champion, 2003). At Lake Hatuma, aerial spraying of willows in 2002 resulted in raupō and *C. secta* being initially “knocked back”, but then expanding in range by 2005 (Walls, 2005). At Opuatia Wetland, aerial spraying of willows in 2006 resulted in high willow mortality, although some tī kōuka in the canopy died and

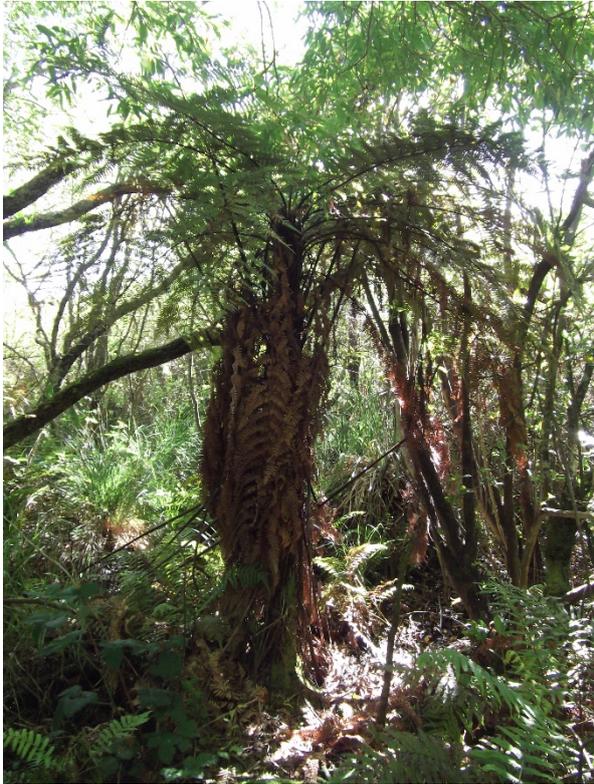
The wetland has mature māhoe, karamu, *Coprosma propinqua* and tī kōuka and strong stands of *Carex secta*, raupō and harakeke, and can reasonably be expected to recover

WHEKĪ, MĀHOE, DIVERSE FERNS AND CAREX SP. UNDER A GREY AND CRACK WILLOW CANOPY. KĀHIKATEA COULD BE RESEEDED UNDER THE WILLOW CANOPY BEFORE WILLOW IS CONTROLLED TO RELEASE KĀHIKATEA SAPLINGS.

well after aerial control of willow. Control of willow will increase light to the wetland floor and enable native seed to germinate and seedlings to survive. The wetland would, however, remain vulnerable to reinvasion until a significant tall canopy is established (*pers. comm.* James Griffiths, Department of Conservation). Grey willow is present in the wider area and seed from this species is likely to reach the wetland in the future.

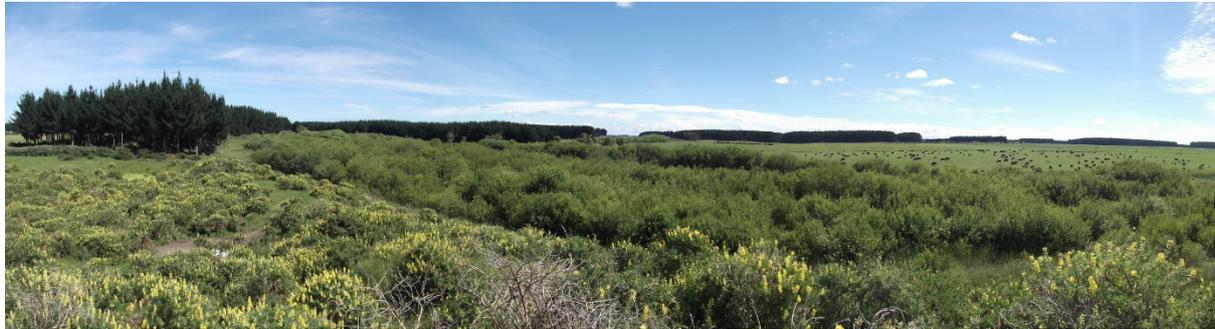
VIEW LOOKING OVER THE GREY AND CRACK WILLOW CANOPY THAT CURRENTLY COVERS THE WETLAND. THIS COULD BE RETURNED TO TALL KĀHIKATEA FOREST THAT WOULD HELP PROTECT THE WETLAND FROM FUTURE WEED INVASION.

Blackberry is present in the wetland at low densities and would increase if willow was controlled, before shade from native species suppressed it again.

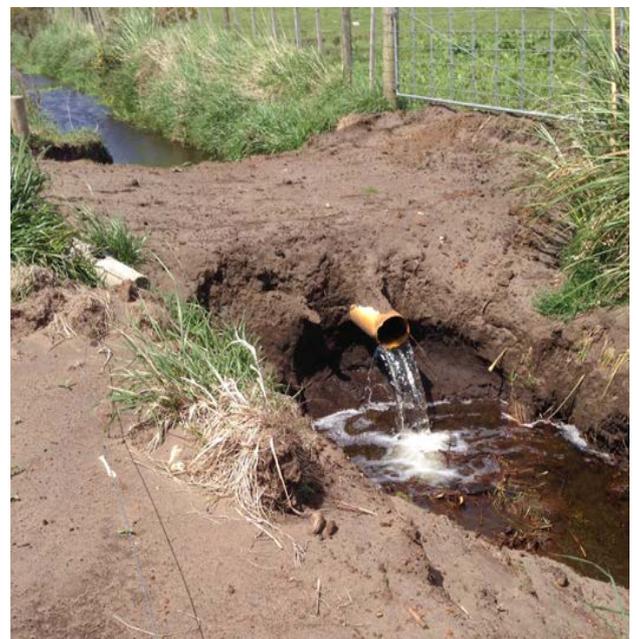
DAM CULVERT

As discussed above, the perched culvert needs to be replaced to allow the stream to return to its main course. This will become higher priority to complete once the downstream blockages have been remedied. Fencing on the true right will also need to be re-erected, especially before stock graze the crops.

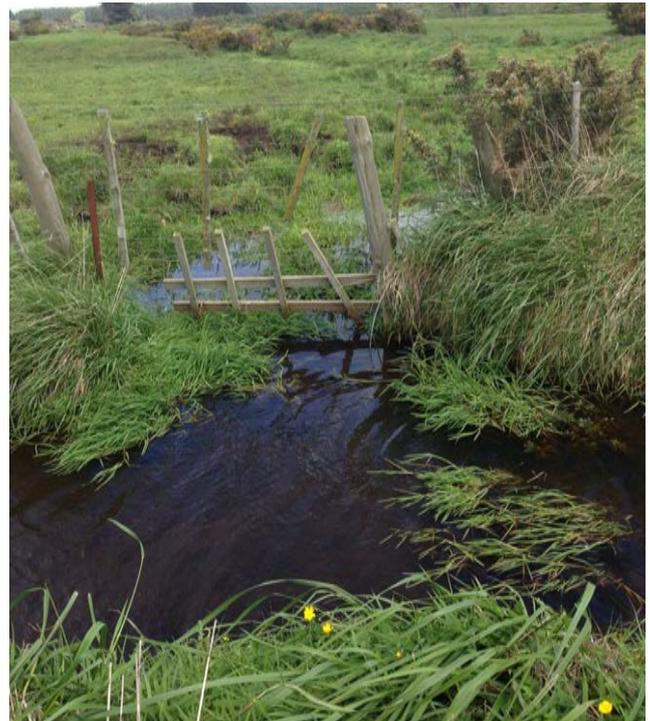
A DUG CHANNEL CONNECTING THE MAIN STEM (IN FOREGROUND) TO THE TRUE LEFT TRIBUTARY (FLOWING AWAY UNDER THE FENCE)

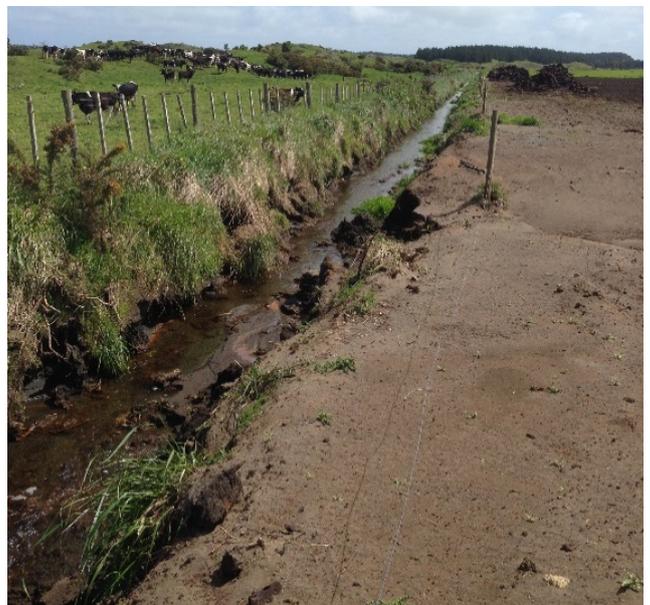
LOWER FLOW BELOW THE CULVERT LOOKING DOWNSTREAM. THE FENCE ON THE TRUE RIGHT NEEDS TO BE REINSTATED. FENCING ON BOTH SIDES OF THE STREAM IS CLOSE TO THE STREAM MEANING RIPARIAN PLANTING CANNOT BE EASILY UNDERTAKEN.

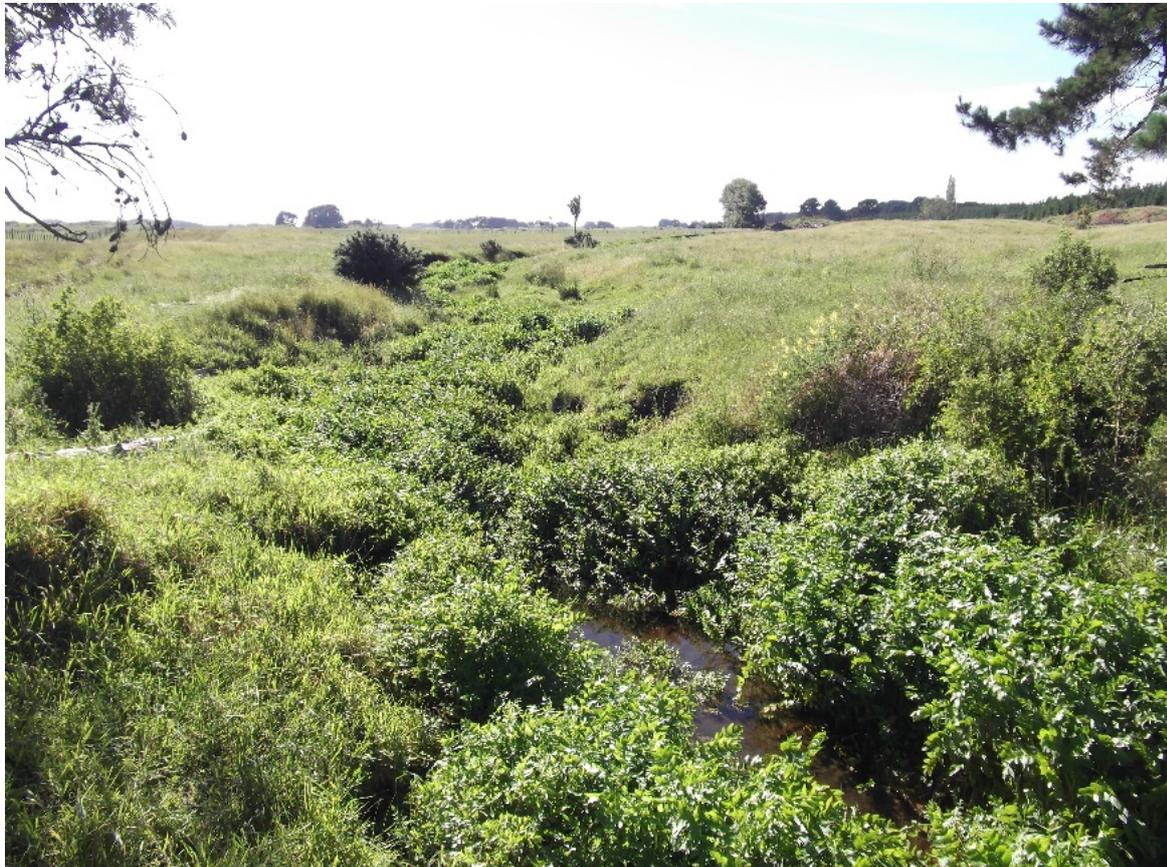
LOOKING UPSTREAM FROM THE LOWER SHELTERBELT / VEHICLE CROSSING. A GOOD POTENTIAL RESTORATION SITE WITH FENCING AND NATIVE PLANTINGS TO COMPETE WITH WATER CELERY. THE SECTION HAS NATURAL MEANDERS, GOOD WATER FLOW AND GOOD POTENTIAL FISH HABITAT IF THE WEIR IN SECTION 3 IS REMOVED.
